Bulletin 403

October, 1937

The Control of Carpenter Ants In Telephone Poles

R. B. FRIEND AND A. B. CARLSON

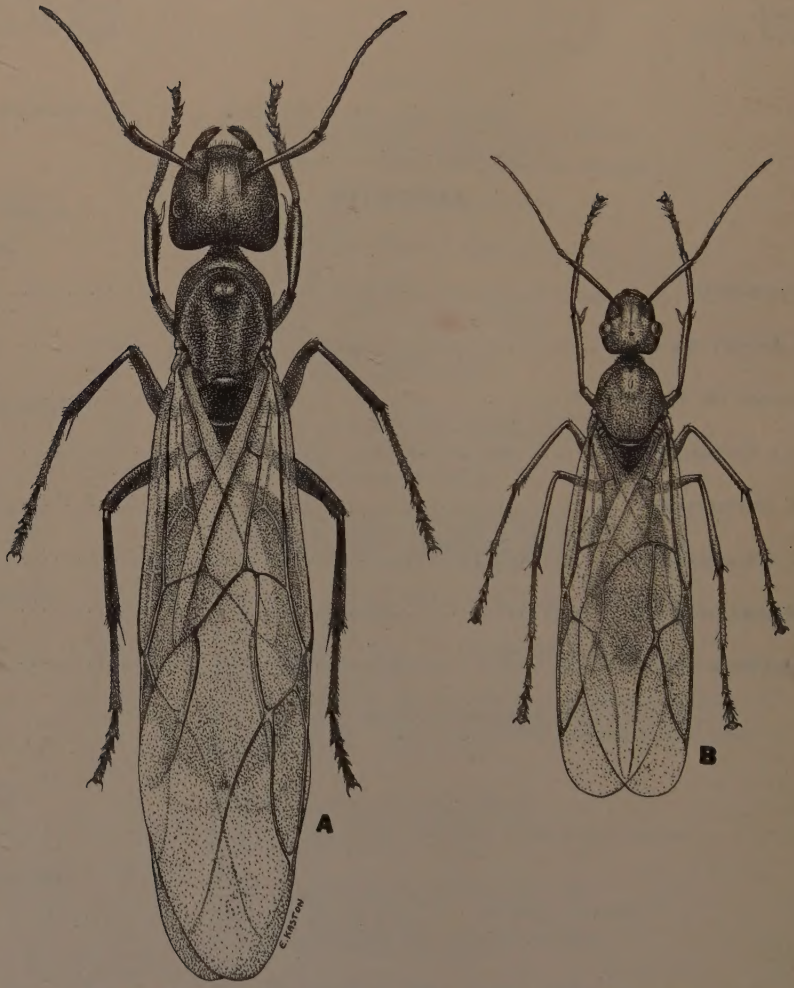
FIGURE 89. A: adult winged female. B: adult winged male. Both enlarged 5 times.

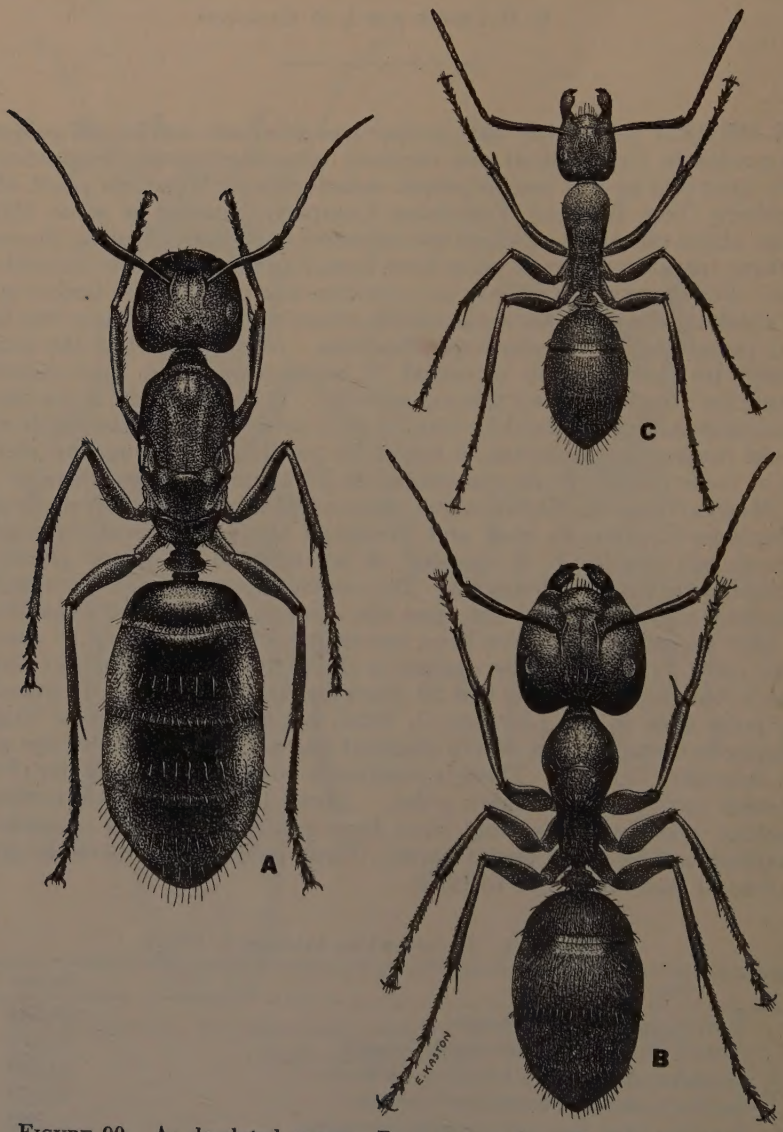
FIGURE 90. A: de-alated queen. B: major worker. C: minor worker. All enlarged 5 times.

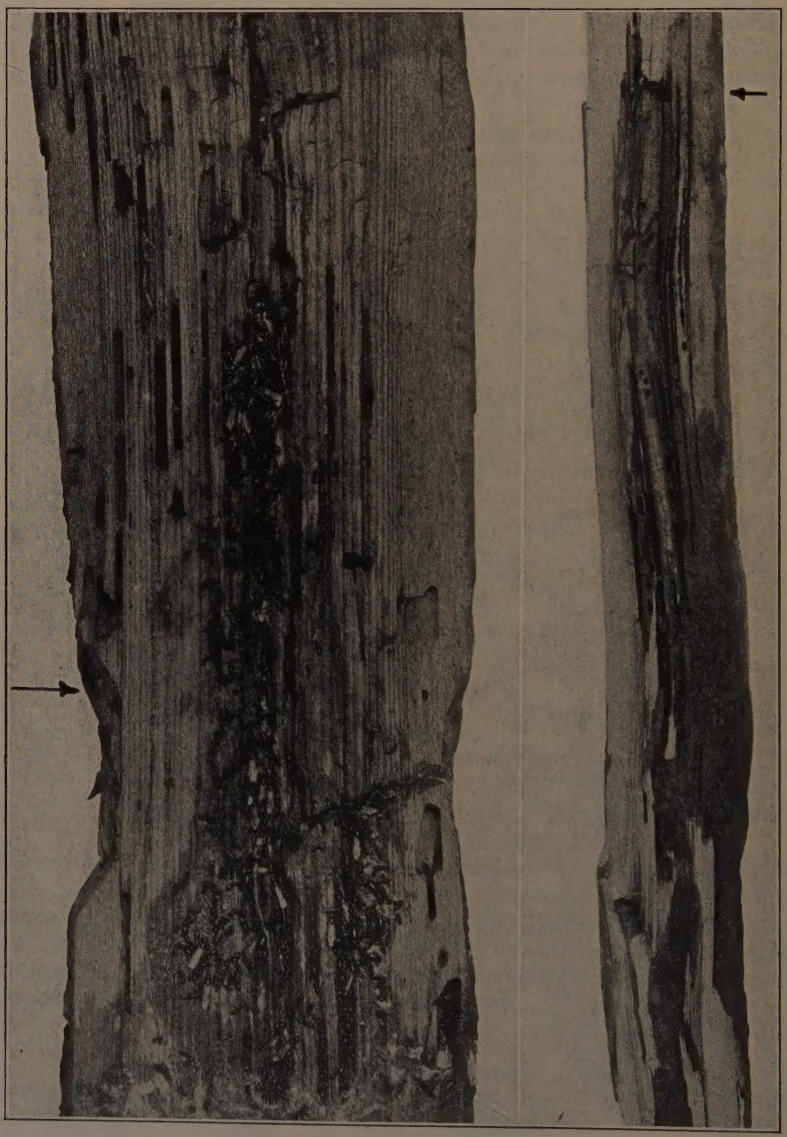
FIGURE 91. Left: carpenter ant colony in telephone pole in winter. The arrow indicates the ground level. The section is about 2 feet long. Right: longitudinal section of a treated pole. The dark stain is due to creosote injected at the level indicated by the arrow. The section is about 4 feet long.

defect, after the colony attains some size the sound wood is extensively excavated. Decayed wood is completely removed, but in sound timber the ants appear to concentrate on the spring wood of the annual ring, although the summer wood is often extensively gnawed away. The result of this in chestnut poles is a typical cavity consisting of three parts. The lower section, where there was originally some decay, has a more or less completely hollow center surrounded by peripheral laminae (Figure 91). Above this is a zone of concentric thin laminae of sound wood (Figures 91 and 92). Extending up from this zone are small galleries which presumably represent a zone of active excavation. The two lower parts constitute the main cavity. Members of an active colony are more numerous in the middle and upper sections and in the periphery of the lower section. The original defect in a pole which permits the establishment of a colony may not be serious, but the later activities of the colony may weaken the pole to such an extent that failure occurs.

hole about 3/8 inch in diameter bored in the pole. This was found to be unsatisfactory, and in all later work a modified "oil-gun", such as used by automobile mechanics, was used to inject liquids. The flexible metal tube attached to the gun was about a foot in length and terminated in a conical tip. The gun was filled by dipping the tip into the liquid and drawing back the piston. The tip was then inserted into the ant cavity through the hole bored in the side of the pole, and the liquid forcibly injected (Figure 94). It was found essential to bore the hole all the way through the top of the ant cavity and to insert the tip of the gun only a short distance beyond the sound shell. An excellent distribution of the material throughout the galleries resulted (Figures 91 and 92). The hole should be plugged with a dowel after treatment.

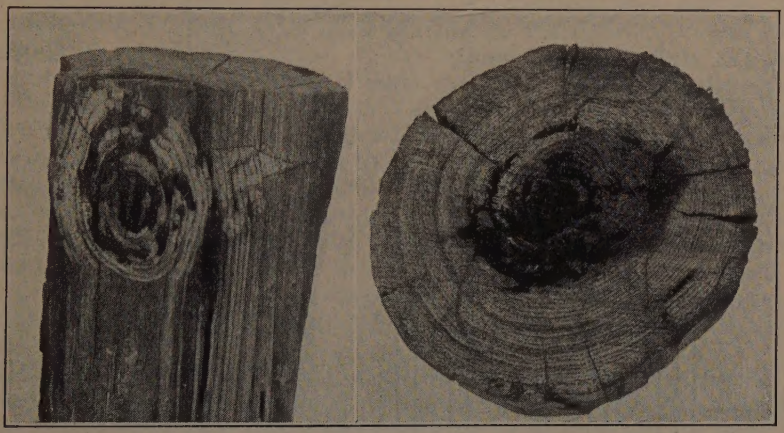
FIGURE 92. Left: section cut at an angle through the laminated part of a carpenter ant cavity in a telephone pole. Right: cross section through a treated ant cavity below the level at which the creosote was applied. The dark stain is due to creosote.

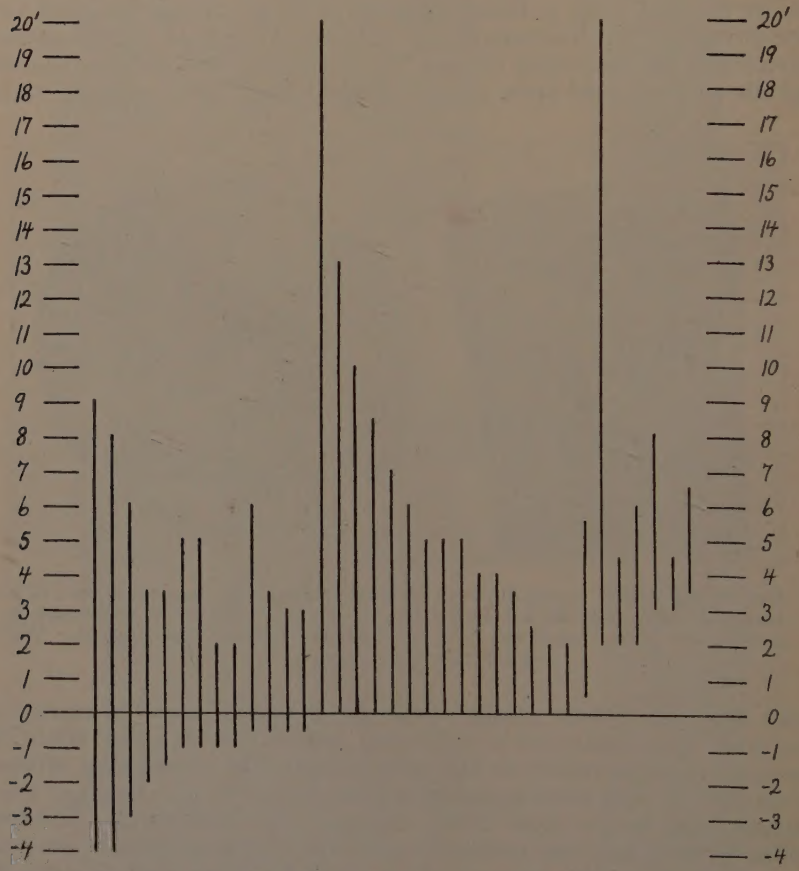
FIGURE 93. Length and position of carpenter ant cavities in 35 telephone poles. Each vertical line represents the extent of one cavity. The figures on each side represent distance in feet from the ground level (horizontal line).

As shown in Figure 93, although the majority of galleries did not extend over six feet above the ground, a few extended much further, two going to about the top of the pole (20 feet in the figure). Sound poles under excess load usually break at the ground line or slightly above it. As indicated in Figure 93, the cavities in the great majority of poles extend from the ground line or a point below it up to two feet or more above ground level. The ants excavate the pole where the greatest strength is needed. There is no correlation between the age of the pole or the presence or absence of butt treatment with creosote and the size of the cavity produced by ants. This is to be expected in view of the frequent inspection of the poles and their condition. Any pole which is so weakened at the time of inspection that failure is likely to occur within three years is marked for replacement. Therefore it is impossible, under these circumstances, to determine either the life of an ant colony in a pole or the maximum possible extent of the galleries.

low minimum requirements. These long cavities are also very likely to have long narrow galleries extending high into the pole and not subject to treatment. Generally speaking, any pole containing an ant cavity which extends over seven feet above the ground line should not be treated but should be replaced.
